29-632

Saab steering wheel control interface

Supported functions

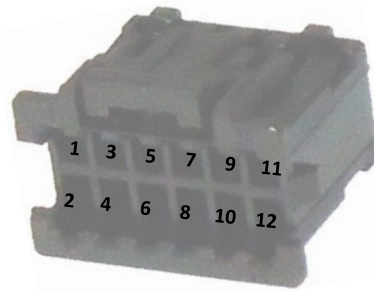
Patch lead wiring configurations

29-000 Self learning units
Single wires pins 1 and 2
No loops
